**Flood Control Project Maintenance  
Levee Inspections**

**Fall 2016 Levee Maintenance Deficiency Summary Report**

**Levee Inspection Report By Mile - Fall 2016**

**Sutter Maintenance Yard East Levee Sutter Bypass**

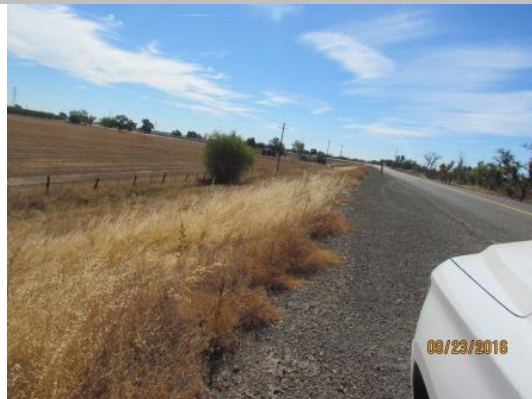
Photo 1 of 1 : FA\_2016\_ST0002\_450\_27\_20161003\_00044.jpg

LM Start	0.01	Rating **	M	Issue No.	27
LM End	0.33	Issue Type +	Ma	Location *	LS
Category	Earthen Levee			GPS Latitude/Longitude	
				Start	End
Item	Vegetation			39.151117 °	39.147405 °
				-121.831953 °	-121.828543 °
DWR ID	DWR_ST0002_01_f_2016_27				
Comment Code					
V1 : Control annual grass and weeds on the levee slopes and easements.					
Inspector Comment

View of the annual grass blocking visibility.

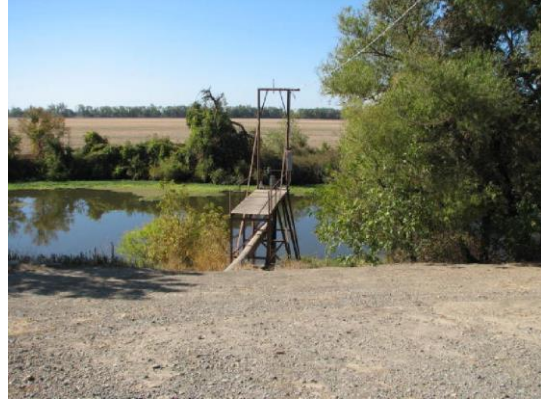
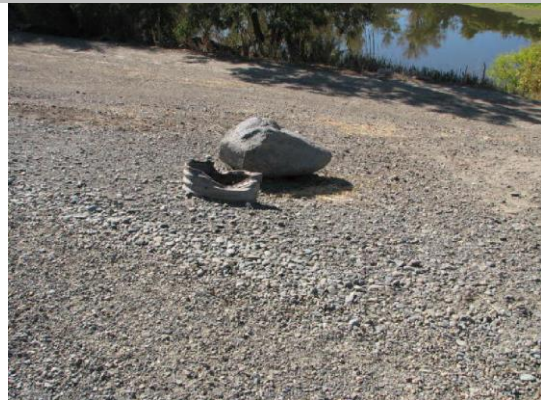
LM Start	<b>1.12</b>	Rating **	M	Issue No.	<b>42 (cont)</b>
LM End	<b>1.12</b>	Issue Type +	En	Location *	LS

Comment Code					
Inspector Comment					
FS_ID:50265 DS_ID:16862 EP_NO: 10932 Repair Type: Non-Urgent Crossing Status: Found UCIP Comments: 10/10/2016 WS CMP riser is still knocked out of place and siphon breaker is suspected to be buried.(DWR Sutter Yard - afreitag)4/18/2016 CMP riser is still knocked out of place and a siphon breaker cannot be found.5/7/2015 24in. cmp riser and siphon breaker were not found on the WS shoulder.11/12/2014 Same as last inspection.5/13/2014 Same as last inspection.10/30/2013 24in. cmp riser was pulled out of levee and there is no sign of a siphon breaker on WS shoulder.5/22/2013 24in. cmp riser on WS shoulder is full of garbage and dirt and should be cleaned out to inspect siphon breaker.10/8/2012 Pier has no walkway to access pump on pier. This is not necessarily an issue. FIELD_STRUCT_DESC: 16-inch steel irrigation pipe through the levee, 6.3 feet below the crown. Vertical pump mounted on a steel structure on the bank. Siphon breaker in a 24-inch corrugated metal pipe riser on the waterside (WS) slope. Concrete distribution box on the landside (LS). Power and communication joint pole (JP) on the WS shoulder. Original equipment in O&M. Hand drawings available in permit. Replaced under (Original O&M entry removed in 1975 and replaced under Permit No. 10932, 1976 - Edward Nall) [Additional Reference(s): DWR Levee Log, 2005. USACE Sacramento O&M Manual 315, May 1953 (Station 1094+80)]. FS Date: 10/11/2016 1:56:34 PM

Pump on metal pier on WS slope.

24-inch CMP riser on WS slope.

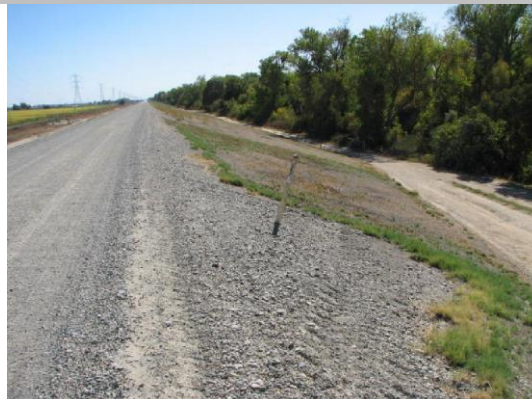
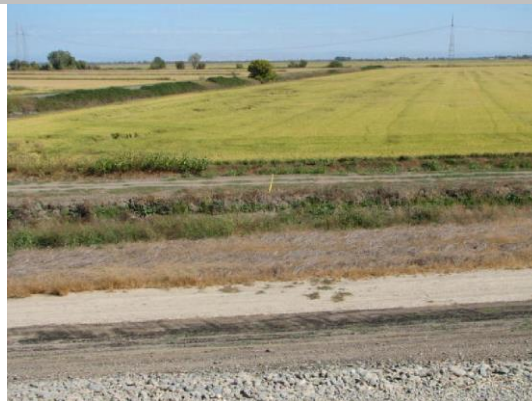
LM Start	<b>7.47</b>	Rating **	M	Issue No.	<b>43 (cont)</b>
LM End	<b>7.47</b>	Issue Type +	En	Location *	WS

FS\_ID:50287  
DS\_ID:19985  
EP\_NO: N/A  
Repair Type: Non-Urgent  
Crossing Status: Found  
UCIP Comments: 10/10/2016 Crossing appears to be in good condition.(DWR Sutter Yard - afreitag)4/18/2016 Crossing appears in good condition. No noticeable issues to report.5/7/2015 Crossing is in good condition. No noticeable issues to report.11/12/2014 Same as last inspection.5/13/2014 Same as last inspection.10/30/2013 Same as last inspection.5/22/2013 Same as last inspection.10/8/2012 No Permit identified for crossing.  
FIELD\_STRUCT\_DESC: Gas-line crosses levee at an unknown depth below the crown. Carsonite sign located on the waterside (WS) shoulder and at landside (LS) toe across toe ditch. Line is owned by Calpine Pipeline Company. No permit has been identified since crossing was field discovered in 2012.  
FS Date: 10/11/2016 2:50:06 PM

Gasline marker on WS shoulder.

Gasline marker on LS toe east of ditch.

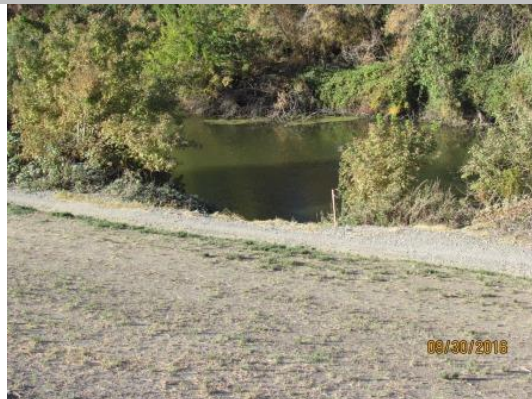
Photo 1 of 1 : FA\_2016\_ST0002\_450\_34\_20161003\_00047.jpg

LM Start	7.83	Rating **	A/W	Issue No.	34
LM End	7.83	Issue Type +	Ma	Location *	WS
Category	Earthen Levee			GPS Latitude/Longitude	
				Start	End
Item	Erosion / Bank Caving			39.067299 °	39.067299 °
				-121.742851 °	-121.742851 °
DWR ID	DWR_ST0002_01_f_2016_34				
Comment Code					
E1 : Note and monitor erosion site.					
Inspector Comment

View of the erosion along the waterside toe.

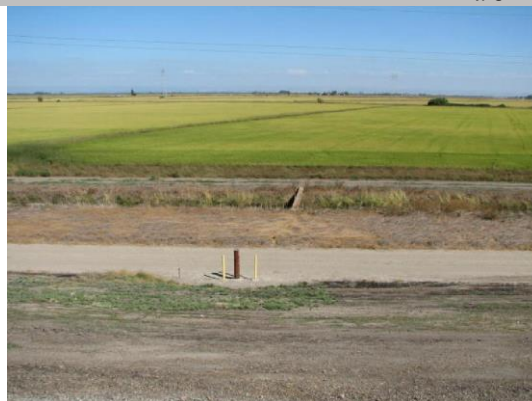
Photo 1 of 2 : UCIP\_FA\_2016\_50288\_65215.jpg

Comment Code					
Inspector Comment					
FS_ID:50288 DS_ID:19984 EP_NO: N/A Repair Type: Non-Urgent Crossing Status: Found UCIP Comments: 10/10/2016 Crossing appears to be in good condition.(DWR Sutter Yard - afreitag)4/18/2016 Crossing appears in good condition. No noticeable issues to report.5/7/2015 Crossing is in good condition. No noticeable issues to report.11/12/2014 Same as last inspection.5/13/2014 Same as last inspection.10/30/2013 Same as last inspection.5/22/2013 Same as last inspection.10/8/2012 No permit or purpose identified for this crossing. FIELD_STRUCT_DESC: 2.5-inch steel pipe bored under the levee at an unknown depth below the crown. Pipe has locked cap on the landside (LS) toe. Steel I-beam stream crossing on the LS toe mark location of pipe. Waterside (WS) marker of pipe crossing is not identified. No permit has been identified since crossing was field discovered in 2012. FS Date: 10/11/2016 2:51:00 PM

Pipe at steel i-beam crossing in ditch at LS toe.

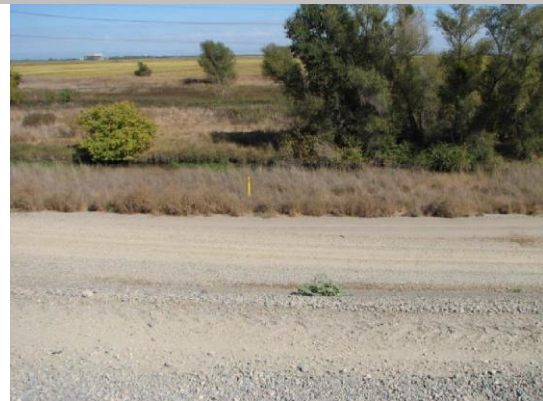
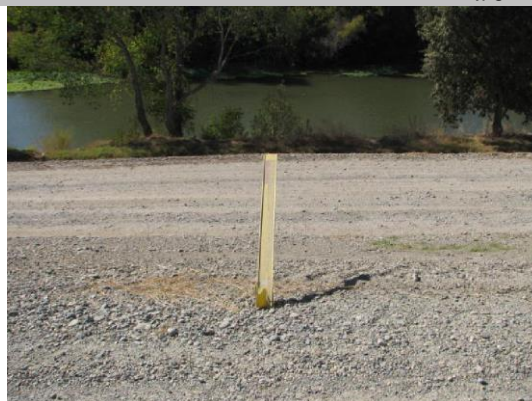
Comment Code					
Inspector Comment					
FS_ID:50290 DS_ID:16884 EP_NO: 14455 Repair Type: Urgent Crossing Status: Indicator Found UCIP Comments: 10/18/2016 it is unknown if the damage to the levee toe from the farmer getting his tractor stuck has been repaired (DWR UCIP - thatch) 10/10/2016 Crossing appears to be in good condition but im not sure if the damaged pipe section at the WS berm was ever repaired. (DWR Sutter Yard - afreitag)4/18/2016 Gas line was damaged at the WS berm due to a farmer getting his tractor stuck. Gas company is aware of the damage and will be doing repairs sometime this summer. Damage should not affect the integrity of the levee. (DWR Sutter Yard - afreitag)5/7/2015 Marker on WS broken. (DWR Sutter Yard - afreitag)11/12/2014 Same as last inspection. (DWR Sutter Yard - afreitag)5/13/2014 Same as last inspection. (DWR Sutter Yard - afreitag)10/30/2013 Same as last inspection. (DWR Sutter Yard - afreitag)5/22/2013 Carsonite marker on WS shoudler is broken and should be replaced. (DWR Sutter Yard - afreitag) FIELD_STRUCT_DESC: 1 of 3. 4.5-inch steel natural gas pipe lines through the levee, 2 feet below the crown. Pipes were paced in same trench 1-foot apart. Gasline markers located on the landside (LS) toe and waterside (WS) shoulder. (Permit No. 14455, 1986 - Depco, Inc.) FS Date: 10/11/2016 2:56:22 PM

Gasline markers on LS toe .

FS\_ID:50290  
DS\_ID:16884  
EP\_NO: 14455  
Repair Type: Urgent  
Crossing Status: Indicator Found  
UCIP Comments: 10/18/2016 it is unknown if the damage to the levee toe from the farmer getting his tractor stuck has been repaired (DWR UCIP - thatch)  
10/10/2016 Crossing appears to be in good condition but im not sure if the damaged pipe section at the WS berm was ever repaired. (DWR Sutter Yard - afreitag)4/18/2016 Gas line was damaged at the WS berm due to a farmer getting his tractor stuck. Gas company is aware of the damage and will be doing repairs sometime this summer. Damage should not affect the integrity of the levee. (DWR Sutter Yard - afreitag)5/7/2015 Marker on WS broken. (DWR Sutter Yard - afreitag)11/12/2014 Same as last inspection. (DWR Sutter Yard - afreitag)5/13/2014 Same as last inspection. (DWR Sutter Yard - afreitag)10/30/2013 Same as last inspection. (DWR Sutter Yard - afreitag)5/22/2013 Carsonite marker on WS shoudler is broken and should be replaced. (DWR Sutter Yard - afreitag)

Gasline markers on WS shoulder.

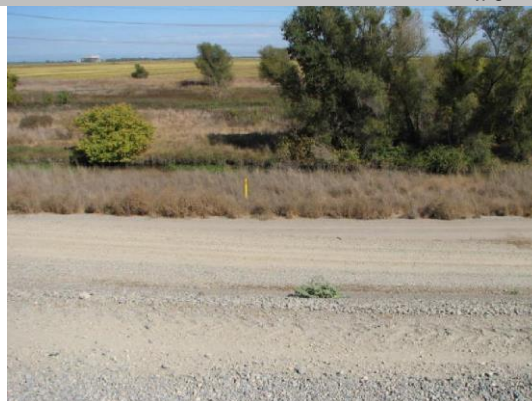
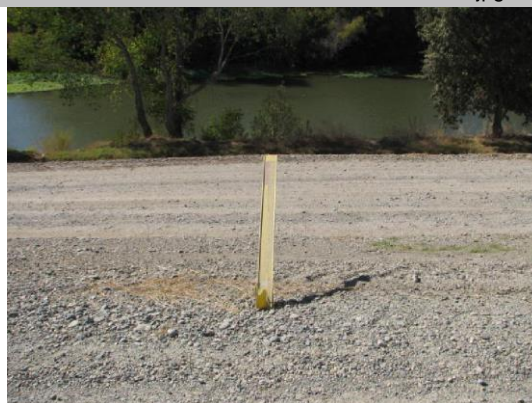
LM Start	<b>10.28</b>	Rating **	U	Issue No.	<b>46 (cont)</b>
LM End	<b>10.28</b>	Issue Type +	En	Location *	WS

FS\_ID:50291  
DS\_ID:16899  
EP\_NO: 14455  
Repair Type: Urgent  
Crossing Status: Indicator Found  
UCIP Comments: 10/18/2016 it is unknown if the damage to the levee toe from the farmer getting his tractor stuck has been repaired (DWR UCIP - thatch)  
10/10/2016 Crossing appears to be in good condition but im not sure if the damaged pipe section at the WS berm was ever repaired. (DWR Sutter Yard - afreitag)4/18/2016 Gas line was damaged at the WS berm due to a farmer getting his tractor stuck. Gas company is aware of the damage and will be doing repairs sometime this summer. Damage should not affect the integrity of the levee. (DWR Sutter Yard - afreitag)5/7/2015 Marker on WS broken. (DWR Sutter Yard - afreitag)11/12/2014 Same as last inspection. (DWR Sutter Yard - afreitag)5/13/2014 Same as last inspection. (DWR Sutter Yard - afreitag)10/30/2013 Same as last inspection. (DWR Sutter Yard - afreitag)5/22/2013 Carsonite marker on WS shoulder is broken and should be replaced. (DWR Sutter Yard - afreitag)

Gasline markers on LS toe.

Gasline markers on WS shoulder.

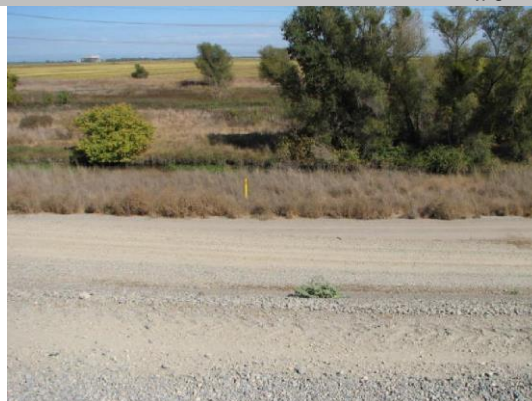
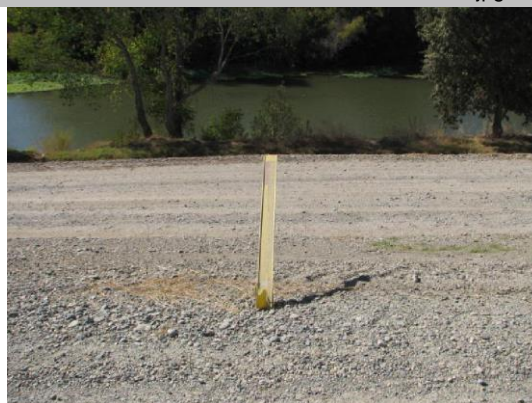
LM Start	10.28	Rating **	U	Issue No.	47 (cont)
LM End	10.28	Issue Type +	En	Location *	WS

FS\_ID:50292  
DS\_ID:16900  
EP\_NO: 14455  
Repair Type: Urgent  
Crossing Status: Indicator Found  
UCIP Comments: 10/18/2016 it is unknown if the damage to the levee toe from the farmer getting his tractor stuck has been repaired (DWR UCIP - thatch)  
10/10/2016 Crossing appears to be in good condition but im not sure if the damaged pipe section at the WS berm was ever repaired. (DWR Sutter Yard - afreitag)4/18/2016 Gas line was damaged at the WS berm due to a farmer getting his tractor stuck. Gas company is aware of the damage and will be doing repairs sometime this summer. Damage should not affect the integrity of the levee. (DWR Sutter Yard - afreitag)5/7/2015 Marker on Ws broken. (DWR Sutter Yard - afreitag)11/12/2014 Same as last inspection. (DWR Sutter Yard - afreitag)5/13/2014 Same as last inspection. (DWR Sutter Yard - afreitag)10/30/2013 Same as last inspection. (DWR Sutter Yard - afreitag)5/22/2013 Carsonite marker on WS shoulder is broken and should be replaced. (DWR Sutter Yard - afreitag)

Gasline markers on LS toe.

Gasline markers on WS shoulder.

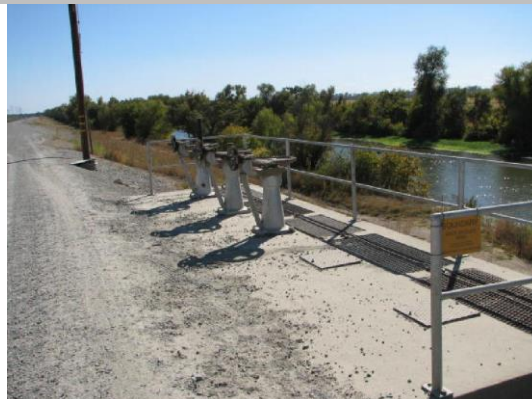
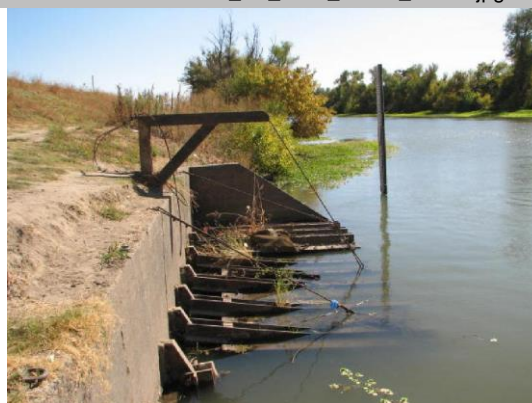
LM Start	<b>10.83</b>	Rating **	M	Issue No.	<b>48 (cont)</b>
LM End	<b>10.83</b>	Issue Type +	En	Location *	WS

FS\_ID:50299  
DS\_ID:16871  
EP\_NO: N/A  
Repair Type: Non-Urgent  
Crossing Status: Found  
UCIP Comments: 10/10/2016 Abandoned crossing.4/18/2016  
Abandoned crossing but no noticeable issues seen with it.5/7/2015  
Abandoned crossing but no noticeable issues with it.11/12/2014  
Same as last inspection.5/13/2014 Same as last  
inspection.10/30/2013 Same as last inspection.5/22/2013 Same as  
last inspection.10/8/2012 Need to determine type of abandonment.  
FIELD\_STRUCT\_DESC: \*ABANDONED\* [Pumping Plant No. 2] 1 of 5.  
4-foot by 6-foot concrete drainage culvert through the levee, 31.5 feet  
below the crown. Wood flap gate and concrete headwall on the  
waterside (WS) end. Wooden steps on the landside (LS) slope.  
Concrete steps on the WS end. [Additional Reference(s): DWR Levee  
Log, 2005. USACE Sacramento O&M Manual 315, May 1953 (Station  
582+19)]  
FS Date: 10/11/2016 3:06:52 PM

Slide gates on WS shoulder

Flap gates on WS toe.

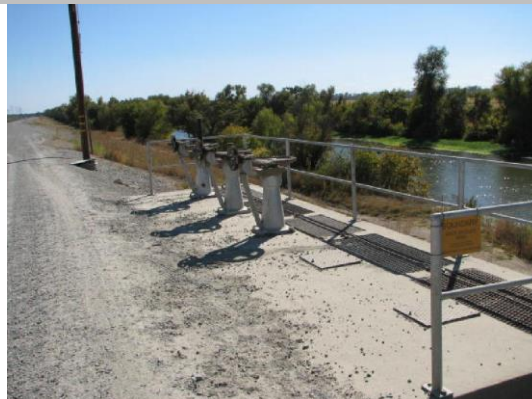
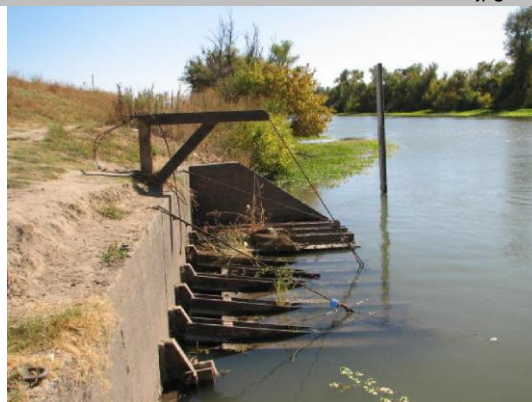
LM Start	<b>10.83</b>	Rating **	M	Issue No.	<b>49 (cont)</b>
LM End	<b>10.83</b>	Issue Type +	En	Location *	WS

FS\_ID:50300  
DS\_ID:16906  
EP\_NO: N/A  
Repair Type: Non-Urgent  
Crossing Status: Found  
UCIP Comments: 10/10/2016 Crossing appears to be in good condition. (DWR Sutter Yard - afreitag)4/18/2016 Abandoned crossing but no noticeable issues seen with it.5/7/2015 Abandoned crossing but no noticeable issues to report.11/12/2014 Same as last inspection.5/13/2014 Same as last inspection.10/30/2013 Same as last inspection.5/22/2013 Same as last inspection.10/8/2012 Determine type of abandonment.  
FIELD\_STRUCT\_DESC: \*ABANDONED\* [Pumping Plant No. 2] 2 of 5. 4-foot by 6-foot concrete drainage culvert through the levee, 31.5 feet below the crown. Wood flap gate and concrete headwall on the waterside (WS) end. Wooden steps on the landside (LS) slope. Concrete steps on the WS end. [Additional Reference(s): DWR Levee Log, 2005. USACE Sacramento O&M Manual 315, May 1953 (Station 582+19)]  
FS Date: 10/11/2016 3:08:13 PM

Slide gates on WS shoulder.

Flap gates on WS toe.

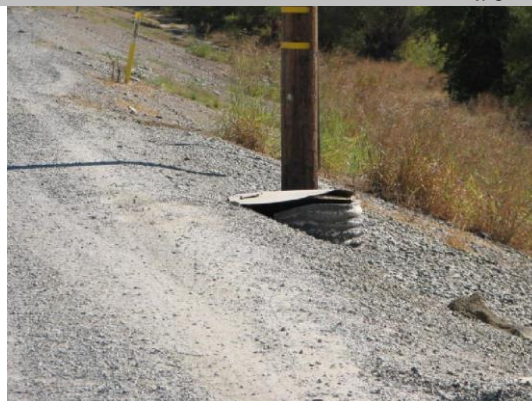
Photo 1 of 1 : UCIP\_FA\_2016\_50305\_65264.jpg

Comment Code					
Inspector Comment					
FS_ID:50305 DS_ID:16872 EP_NO: 3165 Repair Type: Non-Urgent Crossing Status: Found UCIP Comments: 10/10/2016 Abandoned crossing. (DWR Sutter Yard - afreitag)4/18/2016 Abandoned crossing but no noticeable issues to report.5/7/2015 Abandoned crossing. No noticeable issues to report.11/12/2014 Same as last inspection.5/13/2014 Same as last inspection.10/30/2013 Same as last inspection.5/22/2013 Same as last inspection.10/8/2012 Need to determine type of abandonment. FIELD_STRUCT_DESC: *ABANDONED* 10-inch drainage pipe through the levee, 2 feet below the crown. Siphon breaker in a 36-inch corrugated metal pipe (CMP) riser on the waterside (WS) shoulder. Flap gate on the WS end. Minimalistic design drawings available. (Permit No. 3165, 1959 - State of California Department of Water Resources [DWR]). [Additional Reference(s): DWR Levee Log, 2005]. FS Date: 10/12/2016 7:19:31 AM

Siphon breaker in 36-inch CMP riser on WS shoulder. Pipe visible at siphon breaker.

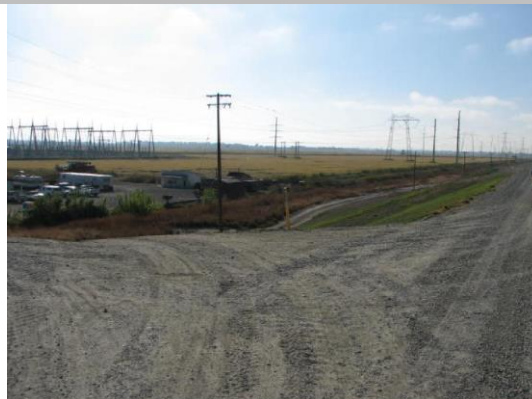
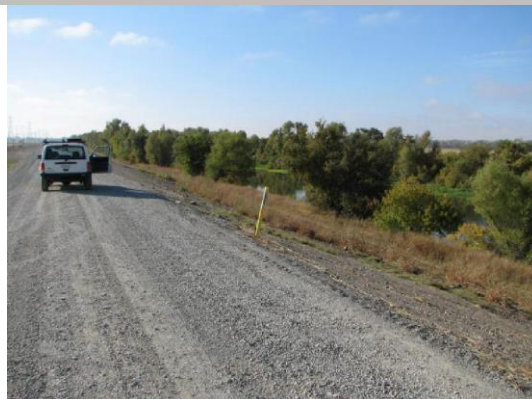
LM Start	<b>10.85</b>	Rating **	M	Issue No.	<b>51 (cont)</b>
LM End	<b>10.85</b>	Issue Type +	En	Location *	WS

FS\_ID:50306  
DS\_ID:19986  
EP\_NO: N/A  
Repair Type: Non-Urgent  
Crossing Status: Indicator Found  
UCIP Comments: 10/10/2016 Crossing appears to be in good condition but there is no permit on file.(DWR Sutter Yard - afreitag)4/18/2016 Crossing appears in good condition. No noticeable issues to report.5/7/2015 Crossing is in good condition. No noticeable issues to report.11/12/2014 Same as last inspection.5/13/2014 Same as last inspection.10/30/2013 Same as last inspection.5/22/2013 Same as last inspection.10/9/2012 No permit identified for crossing.  
FIELD\_STRUCT\_DESC: Gas-line crosses levee at an unknown depth below the crown. Carsonite sign on both landside (LS) and waterside (WS) shoulder. Line is owned by Calpine Pipeline Company. No permit has been identified since crossing was field discovered in 2012.  
FS Date: 10/12/2016 7:21:32 AM

Gasline marker on LS shoulder.

Gasline marker on WS shoulder.

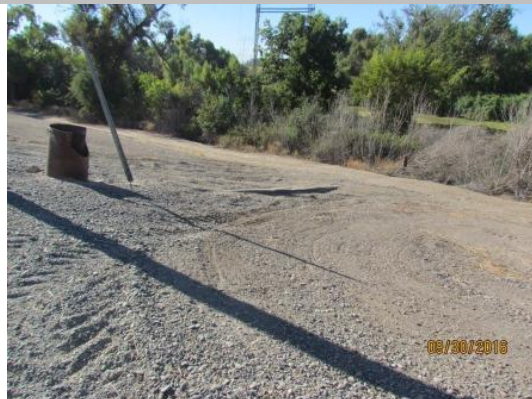
Photo 1 of 1 : FA\_2016\_ST0002\_450\_37\_20161003\_00050.jpg

LM Start	14.71	Rating **	M	Issue No.	37
LM End	14.71	Issue Type +	Ma	Location *	WS
Category	Earthen Levee			GPS Latitude/Longitude	
				Start	End
Item	Slope Stability			38.979389 °	38.979389 °
				-121.691923 °	-121.691923 °
DWR ID	DWR_ST0002_01_f_2016_37				
Comment Code					
S3 : Repair the levee slope damaged by vehicle traffic and prevent access where possible.					
Inspector Comment					
Repair the vehicle erosion along the waterside slope.

View of the erosion caused by vehicle traffic.

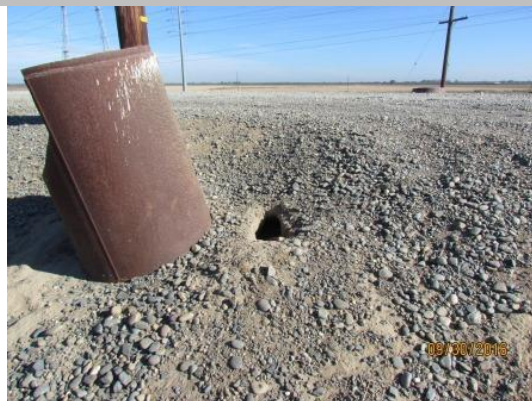
Photo 1 of 1 : FA\_2016\_ST0002\_450\_38\_20161003\_00051.jpg

LM Start	14.71	Rating **	M	Issue No.	38
LM End	14.71	Issue Type +	Ma	Location *	WS
Category	Earthen Levee			GPS Latitude/Longitude	
				Start	End
Item	Animal Control			38.979389 °	38.979389 °
				-121.691923 °	-121.691923 °
DWR ID	DWR_ST0002_01_f_2016_38				
Comment Code					
A3 : No rodents visible, but rodent burrows visible; need to backfill and compact or grout burrows.					
Inspector Comment

View of the rodent holes along the landside slope.

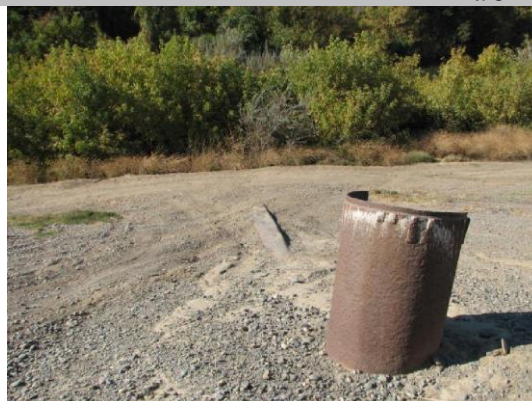
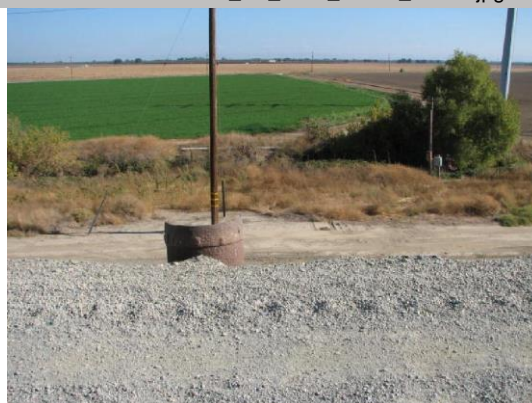
LM Start	<b>14.71</b>	Rating **	M	Issue No.	<b>53 (cont)</b>
LM End	<b>14.71</b>	Issue Type +	En	Location *	WS

FS\_ID:50311  
DS\_ID:16875  
EP\_NO: N/A  
Repair Type: Non-Urgent  
Crossing Status: Found  
UCIP Comments: 10/10/2016 Abandoned crossing.(DWR Sutter Yard - afreitag)4/18/2016 Abandoned crossing.5/7/2015 Abandoned crossing. Needs to be properly abandoned.11/12/2014 Same as last inspection.5/14/2014 Same as last inspection.10/30/2013 Same as last inspection.5/23/2013 Same as last inspection.10/9/2012 Pipe has not been abandoned properly. It should be removed from the levee section.  
FIELD\_STRUCT\_DESC: 16-inch steel irrigation pipe through the levee, 3.5 feet below the crown. Siphon breakers in 30-inch steel risers on both waterside (WS) and landside (LS) shoulders. Vertical pump on pile structure in stream (removed). [Additional Reference(s): DWR Levee Log, 2005. USACE Sacramento O&M Manual 315, May 1953 (Station 377+10)].  
FS Date: 10/12/2016 7:31:23 AM

Pipe on WS slope exposed and crushed below 30-inch steel riser.

Steel riser on LS shoulder.

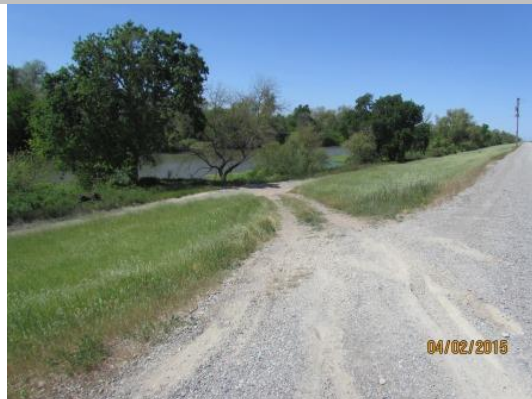
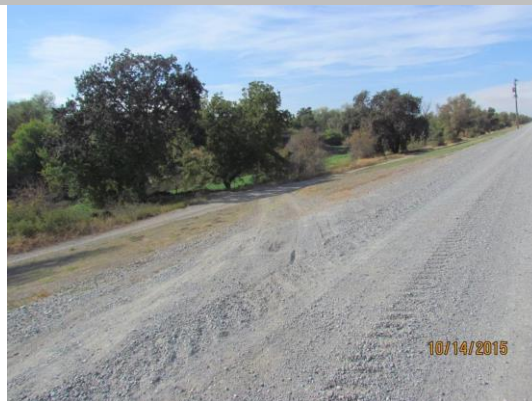
LM Start	17.60	Rating **	M	Issue No.	21 (cont)
LM End	17.60	Issue Type +	Ma	Location *	WS

LM Start	17.60	Rating **	M	Issue No.	21
LM End	17.60	Issue Type +	Ma	Location *	WS
Category	Earthen Levee			GPS Latitude/Longitude	
				Start	End
Item	Slope Stability			38.949965 °	38.949965 °
				-121.653823 °	-121.653823 °
DWR ID	DWR_ST0002_01_s_2015_21				
Comment Code					
S3 : Repair the levee slope damaged by vehicle traffic and prevent access where possible.					
Inspector Comment					
Repair the vehicle erosion along the waterside slope.

View of the vehicle erosion along the waterside slope.

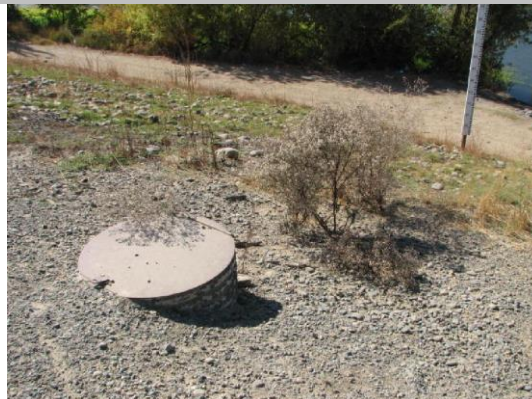
Photo 1 of 1 : UCIP\_FA\_2016\_50319\_65334.jpg

Comment Code					
Inspector Comment					
FS_ID:50319 DS_ID:16878 EP_NO: 3165 Repair Type: Non-Urgent Crossing Status: Found UCIP Comments: 10/10/2016 Abandoned crossing. (DWR Suter Yard-afreitag)4/18/2015 Abandoned crossing. No noticeable issues to report.5/7/2015 Abandoned crossing. No noticeable issues to report.11/12/2014 Same as last inspection.5/14/2014 Same as last inspection.10/30/2013 Same as last inspection.5/23/2013 Same as last inspection.10/9/2012 Need to determine type of abandonment. FIELD_STRUCT_DESC: *ABANDONED* 10-inch steel drainage pipe through the levee, 4 feet below the crown. Siphon breaker in 36-inch corrugated metal pipe (CMP) riser on the waterside (WS) shoulder. Flap gate on the WS end. (Permit No. 3165, 1959 - State of California Department of Water Resources [DWR]) [Additional Reference(s): DWR Levee Log, 2005]. FS Date: 10/12/2016 7:40:38 AM

36-inch CMP riser on WS shoulder.

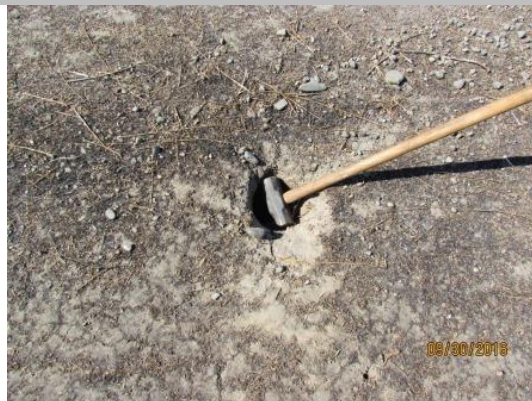
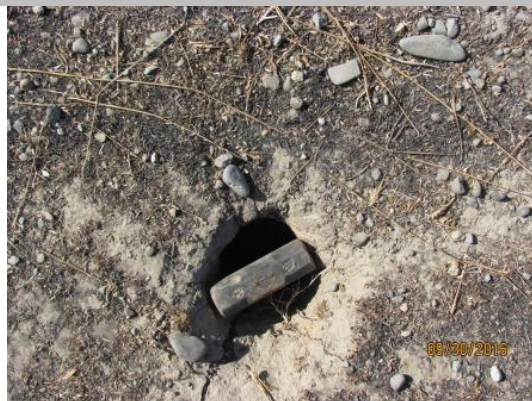
LM Start	19.86	Rating **	U	Issue No.	39
LM End	19.86	Issue Type +	Ma	Location *	LS
Category	Earthen Levee			GPS Latitude/Longitude	
				Start	End
Item	Animal Control			38.924752 °	38.924752 °
				-121.627068 °	-121.627068 °
DWR ID	DWR_ST0002_01_f_2016_39				
Comment Code					
A3 : No rodents visible, but rodent burrows visible; need to backfill and compact or grout burrows.					
Inspector Comment

View of a rodent hole with large hammer sitting on top.

LM Start	19.86	Rating **	U	Issue No.	39 (cont)	
LM End	19.86	Issue Type +	Ma	Location *	LS	
Category	Earthen Levee			GPS Latitude/Longitude		
				Start		End
Item	Animal Control			38.924752 °		38.924752 °
				-121.627068 °		-121.627068 °
DWR ID	DWR_ST0002_01_f_2016_39					
Comment Code						
A3 : No rodents visible, but rodent burrows visible; need to backfill and compact or grout burrows.						
Inspector Comment

Another view of the rodent hole with large hammer hanging in the hole.

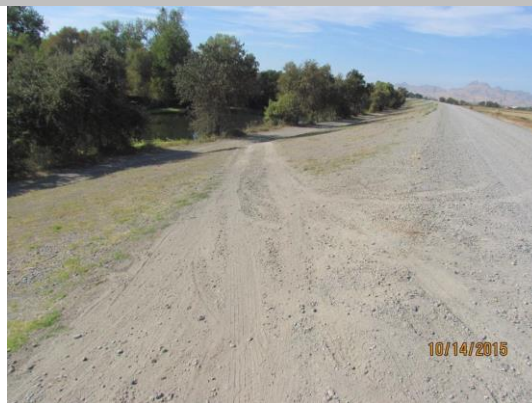
Photo 1 of 1 : FA\_2016\_ST0002\_450\_29\_20160823\_00008.jpg

LM Start	20.02	Rating **	M	Issue No.	29
LM End	20.02	Issue Type +	Ma	Location *	WS
Category	Earthen Levee			GPS Latitude/Longitude	
				Start	End
Item	Slope Stability			38.922678 °	38.922678 °
				-121.625890 °	-121.625890 °
DWR ID	DWR_ST0002_01_f_2015_29				
Comment Code					
S3 : Repair the levee slope damaged by vehicle traffic and prevent access where possible.					
Inspector Comment

View of the vehicle erosion along the waterside slope.

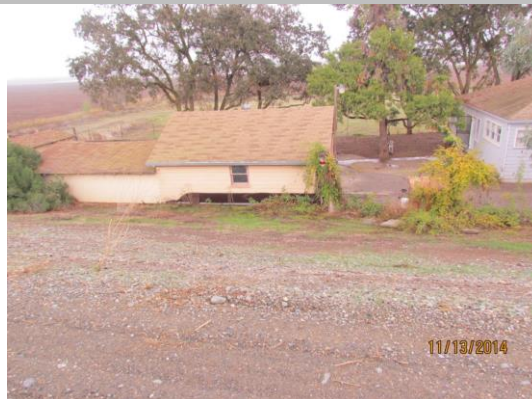
Photo 1 of 1 : FA\_2016\_ST0002\_450\_10\_20160823\_00001.jpg

View of the house next to the toe of the levee.

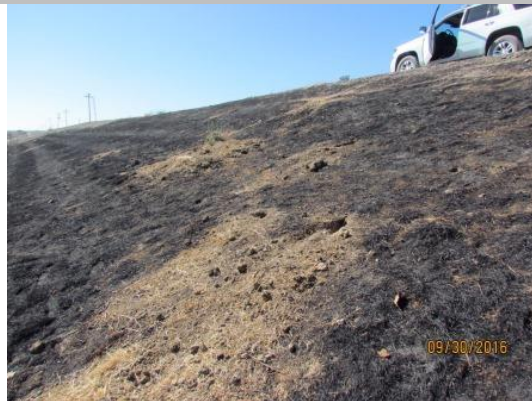
Photo 1 of 1 : FA\_2016\_ST0002\_450\_40\_20161003\_00058.jpg

LM Start	20.43	Rating **	M	Issue No.	40
LM End	20.43	Issue Type +	Ma	Location *	LS
Category	Earthen Levee			GPS Latitude/Longitude	
				Start	End
Item	Animal Control			38.916965 °	38.916965 °
				-121.624048 °	-121.624048 °
DWR ID	DWR_ST0002_01_f_2016_40				
Comment Code					
A1 : Exterminate rodents and backfill and compact or grout burrows.					
Inspector Comment

View of the rodent holes along the landside slope.
